# HOTSPOT ANALYSIS OF PHOTOVOLTAIC MODULE USING EL & IR TECHNIQUES

Saurabh Kumar<sup>1</sup>, Gaurav Kumar<sup>2</sup>

<sup>1</sup>CMJ University, Shillong, India, <sup>2</sup>N.I.T, Kurukshetra, India

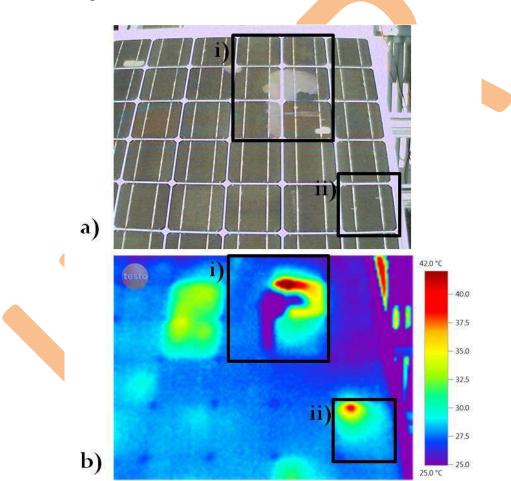
The cell mismatch present in the module results in hot spots which can be seen using infrared imaging techniques. An infrared image of the damaged area of the module is shown in figure 2. along with the optical image. The module has bypass diodes connected across the strings so while the damaged string is not reverse biased by more than +/-0.5 V, the activation voltage of the bypass diodes, the damaged cells will still be reverse biased and dissipating heat. The damaged area in string C is highlighted in region i) in both images. The initial cause of damage

to these cells is not known but could be attributed to a micro crack in the cell that degraded further with thermal cycling resulting in a severely cracked cell. The heat generated by this cell caused the delamination, the encapsulant has separated from the cell and the cell is visibly cracked. The cracked cell area is visible as a cold area in the infrared image. The rest of the cell heats up to over 40°C as the cell is reverse biased. This heating causes the further damage to the cell and the delamination spreads across the surrounding cells. The infrared image of the module shows a hot spot in string B, labelled ii), which is not visible on the front of the module. This hot spot could with time spread and result in delamination and possibly cracked cells like what is seen in string C. Evidence of the hot spot is visible on the back of the module where a bubble has occurred in the encapsulant.

Figure 2 a) Optical image and b) Infrared image of the same portion of the module with damaged portion of string C labelled i) and a hot spot in string B labelled ii).

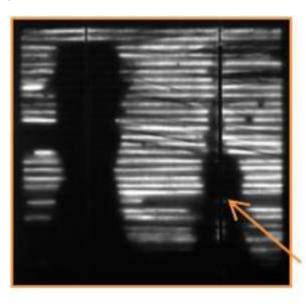
The El image of the delaminated cell is shown in figure 3.

Area of delamination and Moisture Ingress

Figure3: EL image of delaminated cell
