# TEST TO FAILURE STUDY OF PHOTOVOLTAIC MODULE USING EL TECHNIQUE

## ABSTRACT

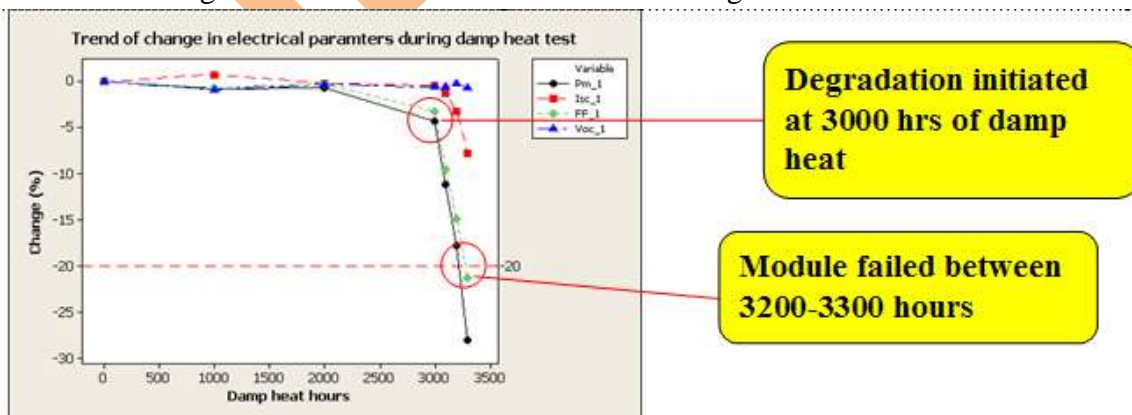
Fig.3: The Trend of change of Electrical Parameters during DH Test

- Up to DH2000, no appreciable change (less than 1%) in power observed.
- From 2000 to 3000 hrs, power degraded rapidly and substantial power loss (more than 4%) observed in both the samples.
- Power degraded rapidly thereafter and crossed failure mark (more than 20% degradation) after 3300 hrs.
- No appreciable change in  $I_{sc}$ . FF reduction is mainly contributing to loss in power.

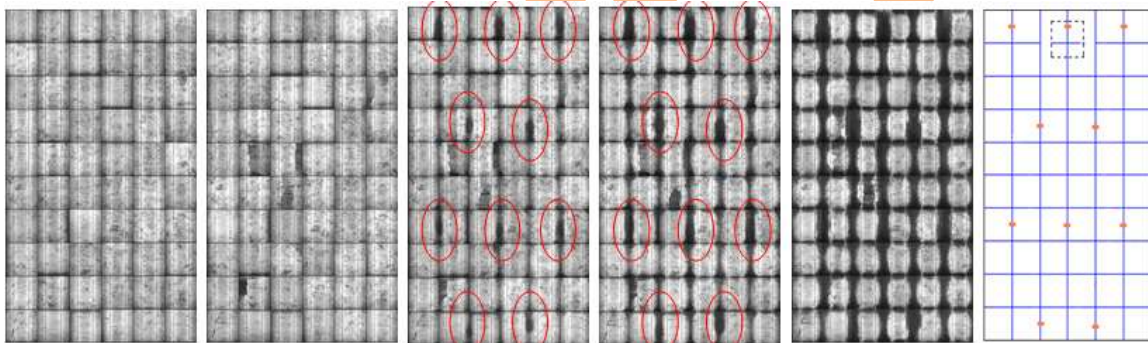
**Figure 4: EL Images of Module during DH test**

- Leaching out of plasticizers liquid additives in prolonged exposure to hot-humid conditions.
- Development of small pores in back sheet leading to moisture penetration into internal layers. Moisture causing hydrolysis (degradation) of PET layer and penetrating inside module active area.

- Moisture ingress resulting in chemical reaction between cell contacts (front or back) and additives in encapsulant leading to ribbon & interconnect detachment and BSF layer degradation.
- Cell matrix tape is aggravating the reaction leading to more degradation.
- Degradation leading to increase in series resistance.

It is clear from images that Moisture ingress through cracked back-sheet degraded AgAl bus bar-silicon adhesion and back aluminum BSF layer.

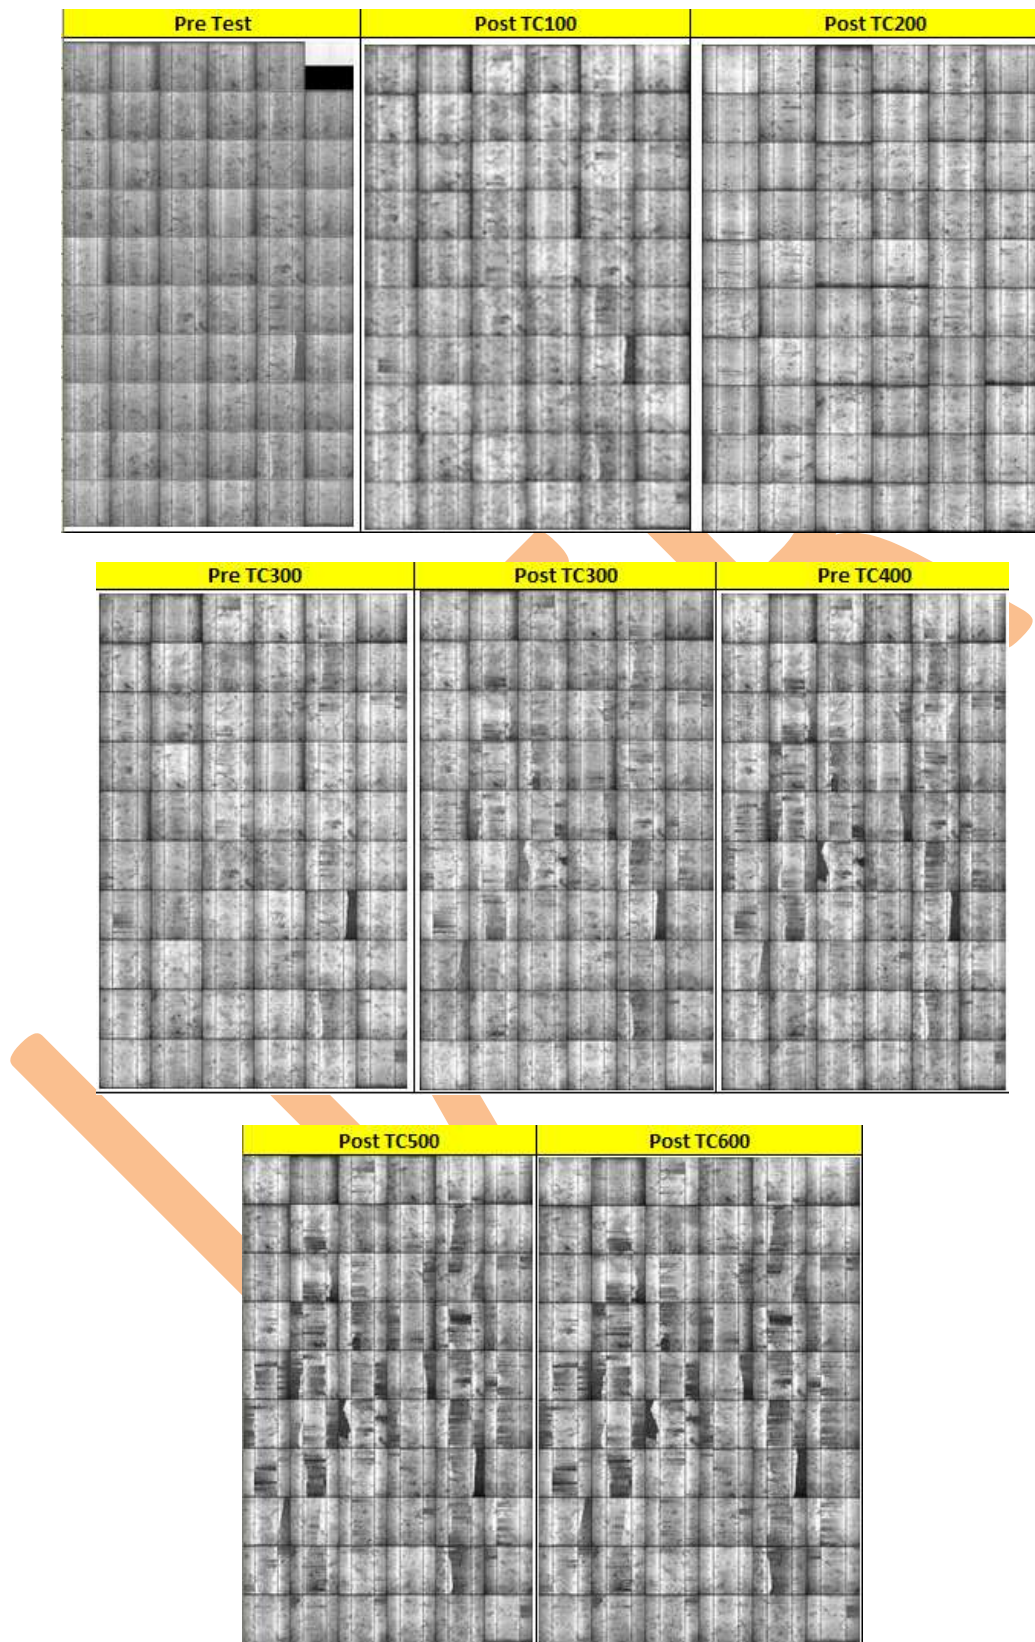
*Fig 6: EL Images of PV Module during TC Tests*

- Post TC300, large no. of visual defects (cracks and hot spots) observed but that didn't lead to substantial power loss.
- Nearly constant degradation in power observed after each batch of 100 thermal cycles. Micro cracks and other defects do not seem to be substantially affecting module's performance.
- Power degradation is mainly driven by loss in fill factor.
- Power loss crossed 5% mark post TC600.
